WHY THE RED/GRAY CHIPS ARE NOT PRIMER PAINT

Niels Harrit, May 09

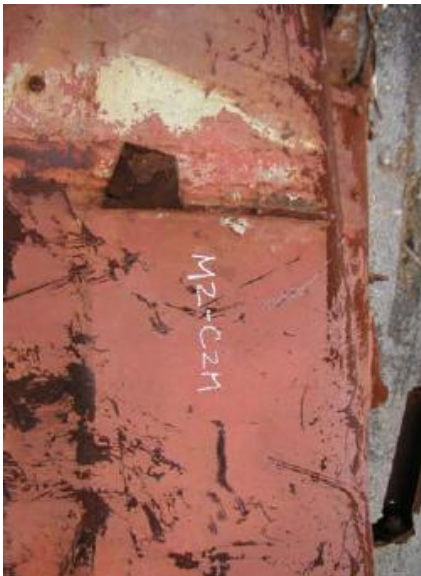
Figure 1. M2-C2M (WTC 1, Col.130, FI 98) from NCSTAR 1-3C appendix D².

Examples of typical beams are shown in Figure 1 and Figure 2.

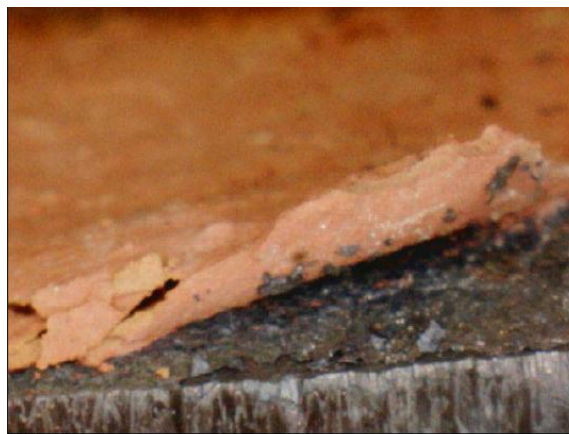
Source: NIST.
Figure D-4. Formation of a black scale between paint and steel after exposure greater than 650 °C. Paint readily spalled.

Figure 8. From NCSTAR 1-3C appendix D² showing formation of a black layer under the primer paint at temperatures beyond 650 °C.

between the paint and the steel (Figure 8). NIST took the samples beyond 800 °C at which temperature the scale formation and peeling off of the paint from the steel was prevailing. One may hypothesize that formation of the black scales is due to charring of the organic binder.
